**SANITARY SEWER SMOKING REPORT
SANITARY SEWER INVESTIGATIONS
DONNELLSON, IOWA
2025**

SANITARY SEWER SMOKING REPORT

DONNELLSON, IOWA

Project No. 24-034

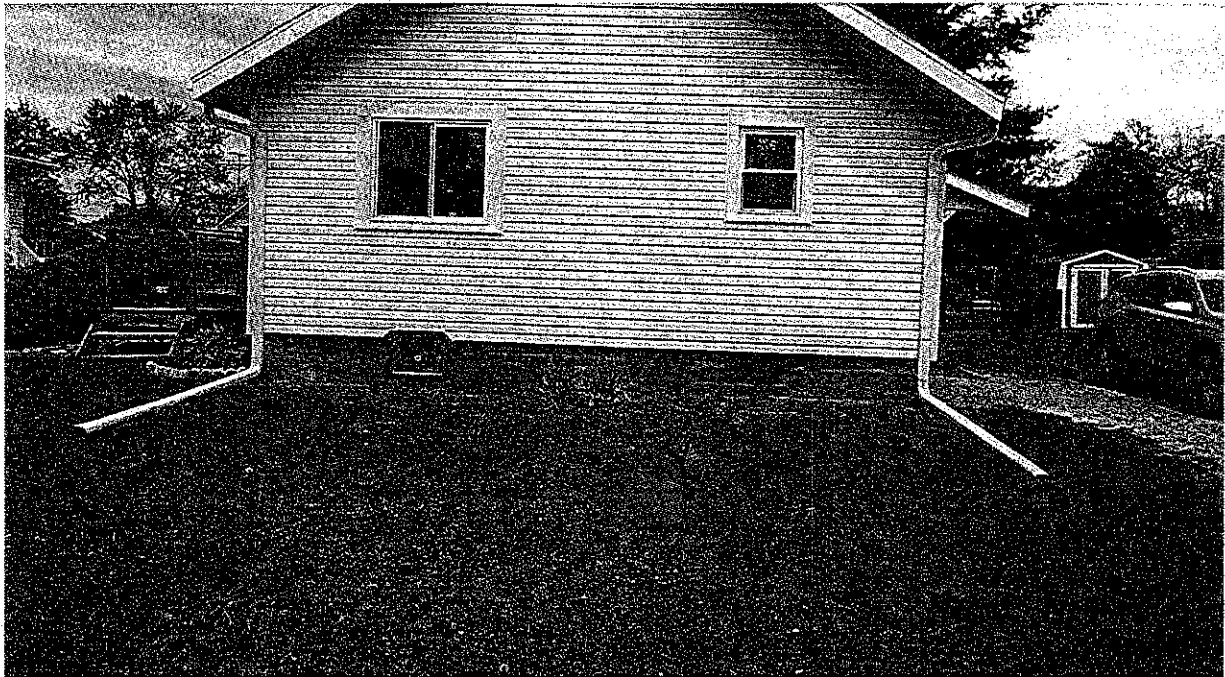
HSE 305 MAPLE — BROKEN SEWER CAP

1. Work with the property owners to have them fix the seven identified defects.
2. Conduct basement inspections to identify illegal connections to the sanitary sewer (sump pumps). Work with the property owners to disconnect sump pumps from the sanitary sewer.
3. Replace manhole castings with open pick holes and install new adjusting rings with chimney seals.
4. Line manholes with signs of I/I.
5. Review sewer videos and consider a sanitary sewer lining or reconstruction project.

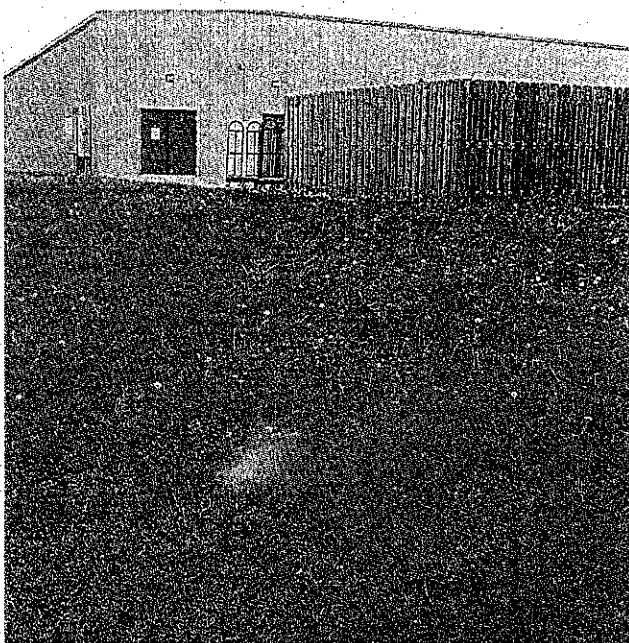
DOLLAR GENERAL — BROKEN SEWER CAP

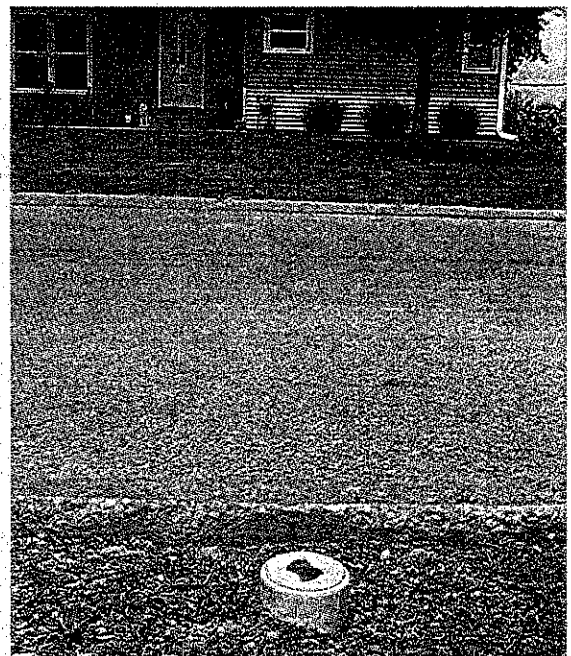
HSE 103 ORCHARD — BROKEN SEWER CAP

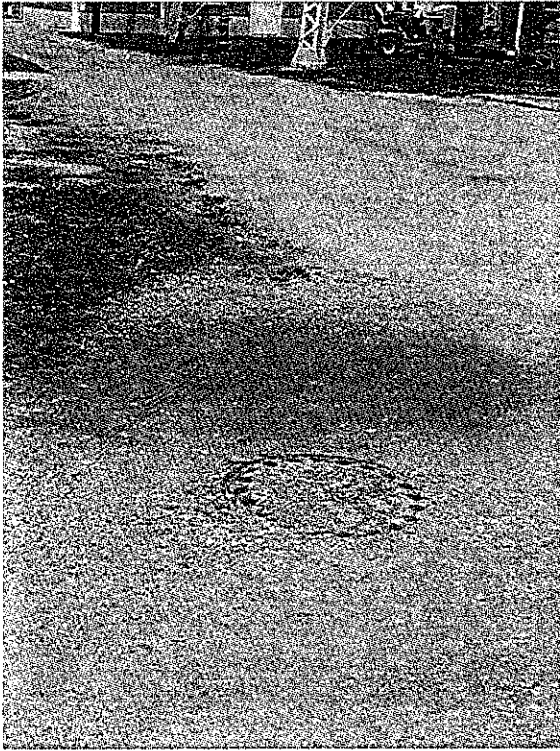
MANHOLE 3-06 SURFACE CONDITIONS

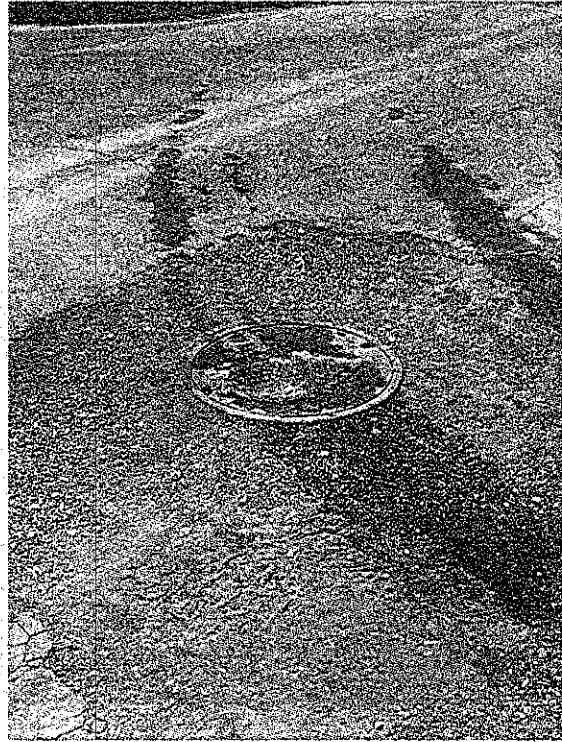
MANHOLE 3-10 SURFACE CONDITIONS

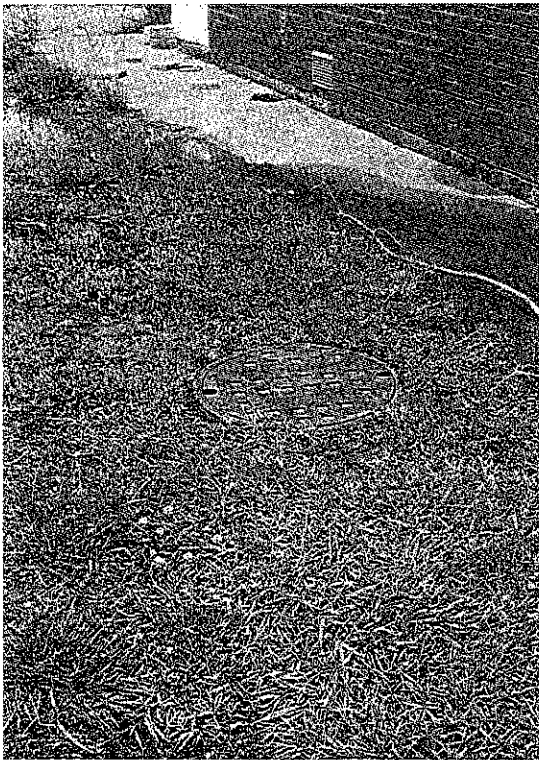
MANHOLE 3-11 SURFACE CONDITIONS

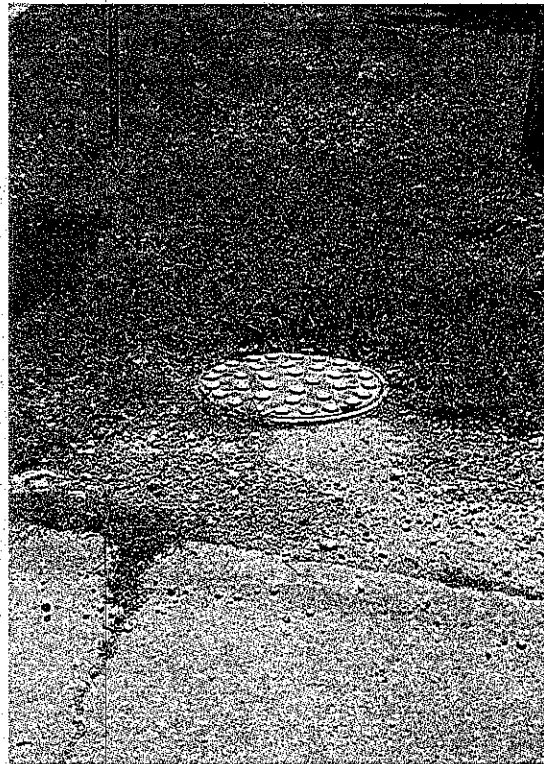
MANHOLE 3-12 SURFACE CONDITIONS

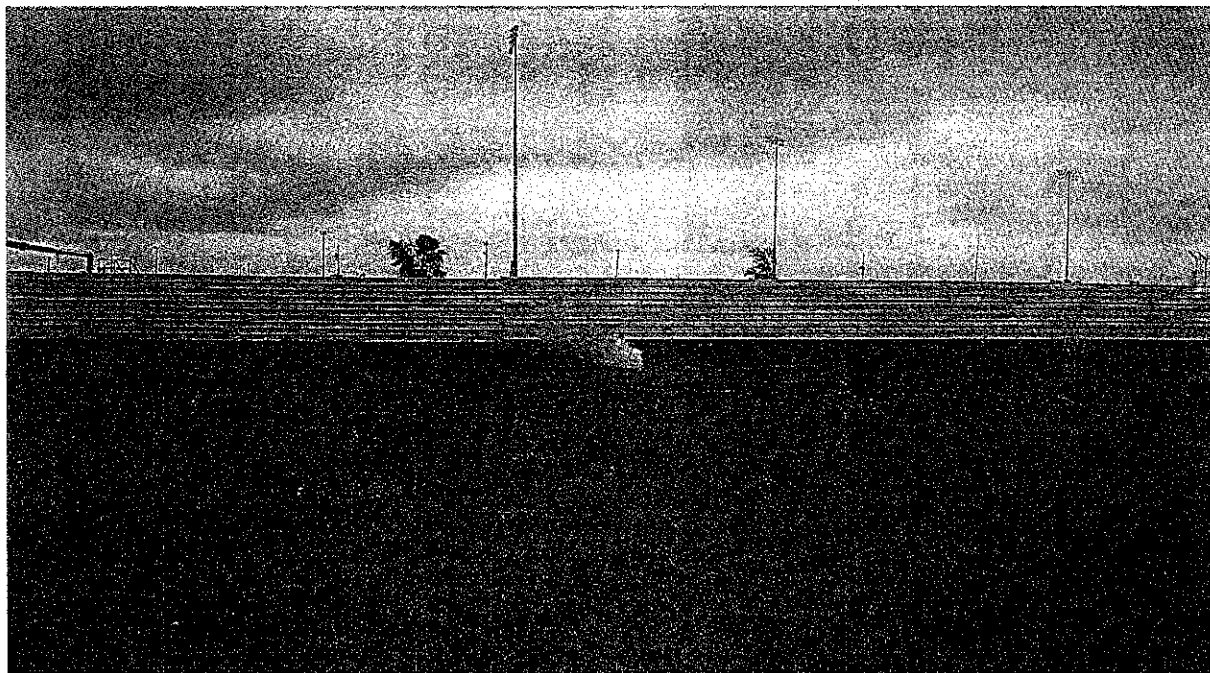
FAIRGROUNDS – BROKEN SEWER CAP

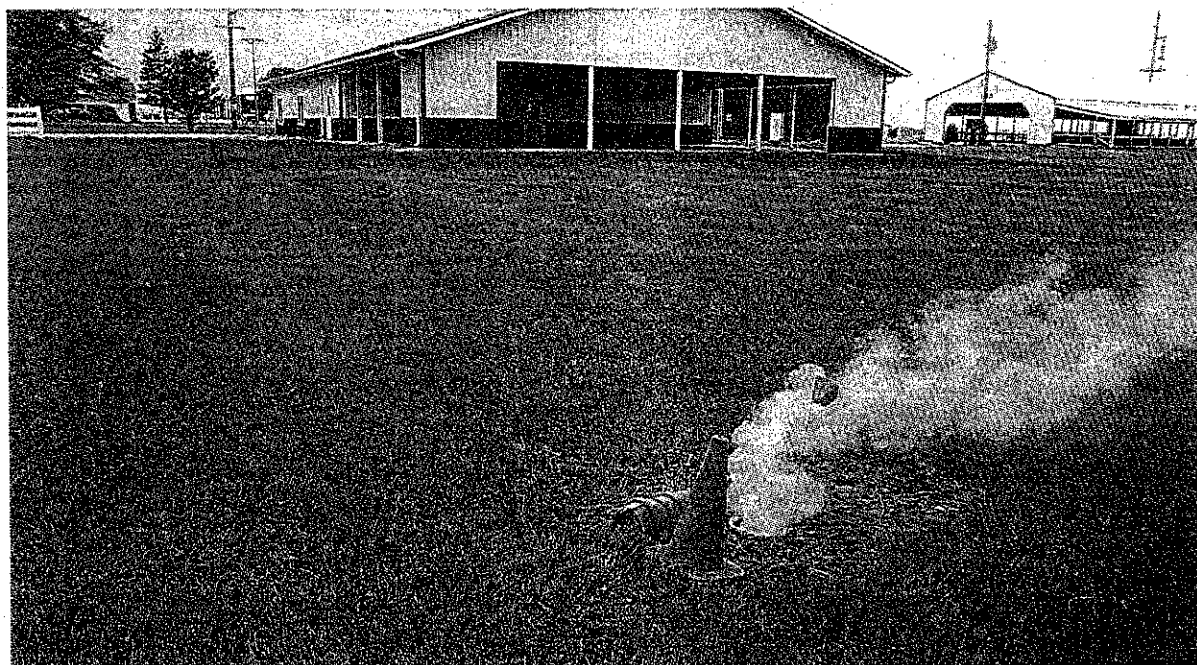
FAIRGROUNDS – BROKEN SEWER CAP
