**SANITARY SEWER SMOKING REPORT
SANITARY SEWER INVESTIGATIONS
DONNELLSON, IOWA
2025**

SANITARY SEWER SMOKING REPORT

DONNELLSON, IOWA

Project No. 24-034

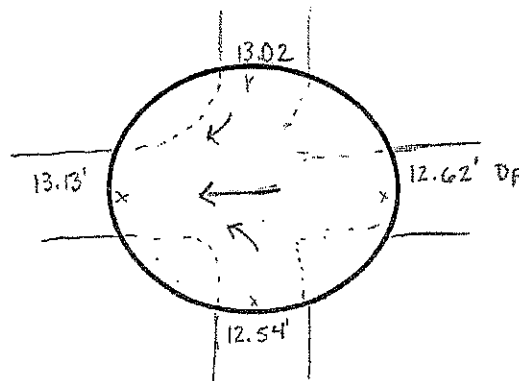
Condition	Material	I/I	Photo ID	Comments
Cover	1 2 ③		0 1 2 3	110-0038	
Frame	1 ② 3		0 1 2 3	110-0165	OPEN PICK HOLE
Chimney	1 2 ③		0 1 2 3		
Corbel	1 2 3		0 1 2 3		
Wall	1 ② 3	BRICK	0 1 2 3		
Bench	1 2 3		0 1 2 3		
Invert	1 ② 3		0 1 2 3		
Steps	① 2 3		0 1 2 3

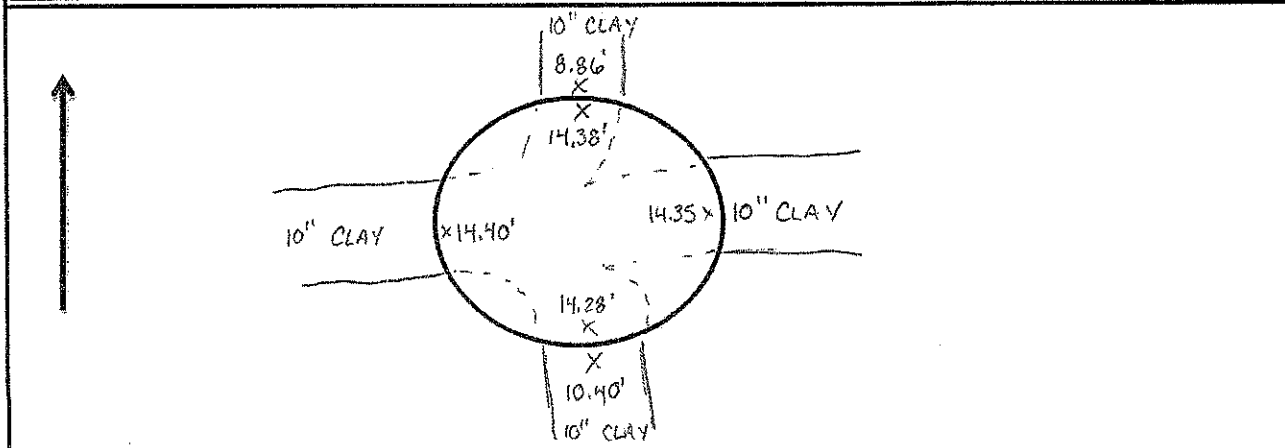
Condition	Material	I/I	Photo ID	Comments
Cover	1 2 <u>3</u>		0 1 2 3	110-0039	
Frame	1 <u>2</u> 3		0 1 2 3	110-0166	Open pick hole
Chimney	1 <u>2</u> 3		0 1 2 3		
Corbel	1 2 3		0 1 2 3		
Wall	1 <u>2</u> 3	BRICK	0 1 2 3		
Bench	1 2 3		0 1 2 3		
Invert	1 <u>2</u> 3		0 1 2 3		
Steps	<u>1</u> 2 3		0 1 2 3

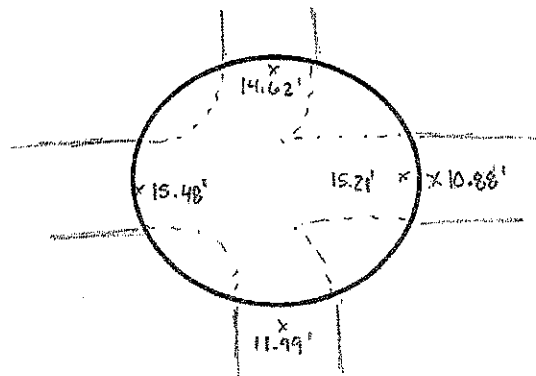
Condition	Material	I/I	Photo ID	Comments
Cover	1 <u>2</u> 3		0 1 2 3	110-0047	
Frame	1 <u>2</u> 3		0 1 <u>2</u> 3	110-0167	Concealed Pick holes
Chimney	1 <u>2</u> 3		0 1 2 3	110-0170	No apparent I/I
Corbel	1 2 3		0 1 2 3		
Wall	1 <u>2</u> 3	BRICK	0 1 2 3		MOISTURE NEAR BOTTOM
Bench	1 2 3		0 1 2 3		
Invert	1 <u>2</u> 3		0 1 2 3		
Steps	<u>1</u> 2 3		0 1 2 3

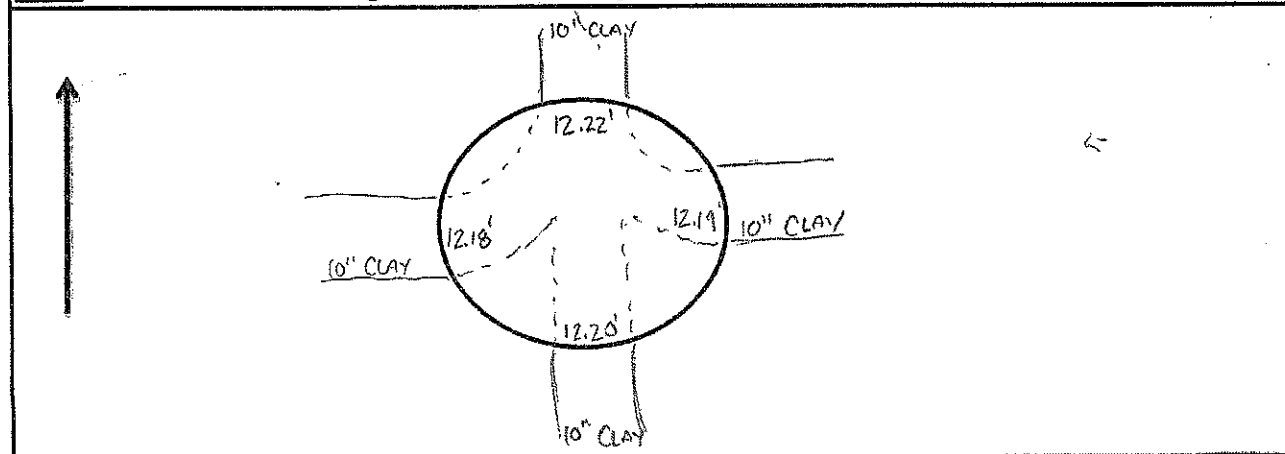
Condition	Material	I/I	Photo ID	Comments
Cover	1 2 (3)		0 1 2 3	110-0044	
Frame	1 2 (3)		0 1 2 3	110-0171	Open Pick holes
Chimney	1 2 (3)		0 1 2 3		SMOKE FROM UNDER FRAME
Corbel	1 2 3		0 1 2 3	110-0172	I/I at Joints
Wall	1 2 (3)	PRECAST	0 1 2 3		SEEPING JOINT 8' FROM BOTTOM
Bench	1 2 3		0 1 2 3		
Invert	1 2 (3)		0 1 2 3		
Steps	1 2 (3)		0 1 2 3

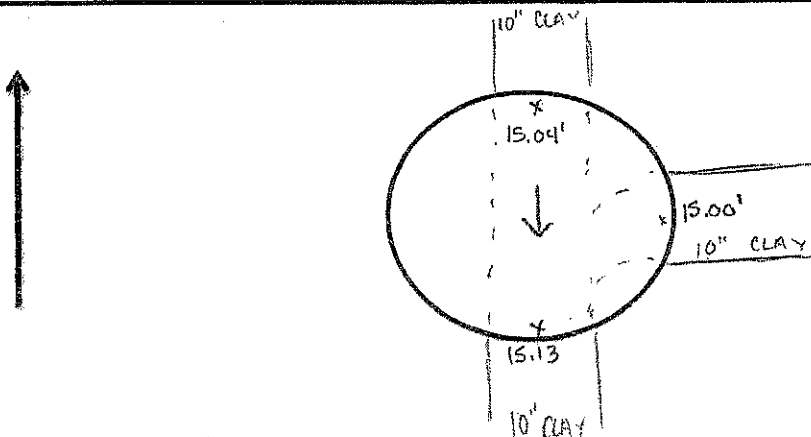
Condition	Material	I/I	Photo ID	Comments
Cover	1 (2) 3		0 1 2 3	110-0052	
Frame	1 (2) 3		0 1 2 3	110-0184	Open Pick Holes
Chimney	1 2 (3)		0 1 2 3	110-0185	
Corbel	1 2 3		0 1 2 3		
Wall	1 (2) 3	LINED BRICK	0 1 2 3	110-0182	MOISTURE BOTTOM 6' ±
Bench	1 2 3		0 1 2 3	110-0182	Open Pick Holes
Invert	1 (2) 3		0 1 2 3	110-0183	
Steps	(1) 2 3		0 1 2 3

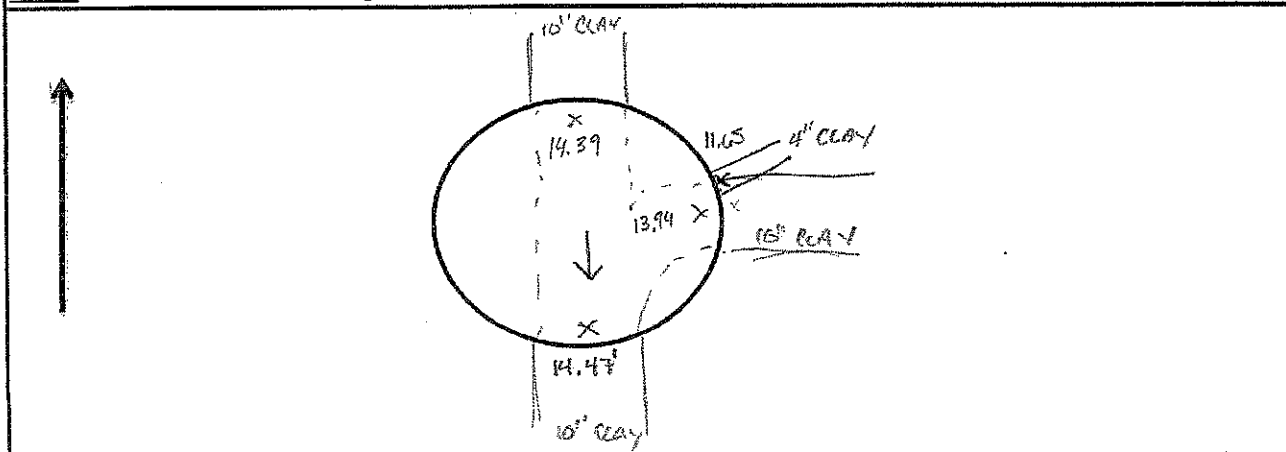
Condition	Material	I/I	Photo ID	Comments
Cover	① 2 3		0 1 2 3	110-0065	
Frame	1 ② 3		0 1 2 3	110-0176	Open Pick holes
Chimney	1 2 ③		0 1 2 3	110-0194	Open Pick holes
Corbel	1 2 3		0 1 2 3		
Wall	1 2 ③	LINED BRICK	0 1 2 3		
Bench	1 2 3		0 1 2 3		
Invert	1 ② 3		0 1 2 3		
Steps	① 2 3		0 1 2 3

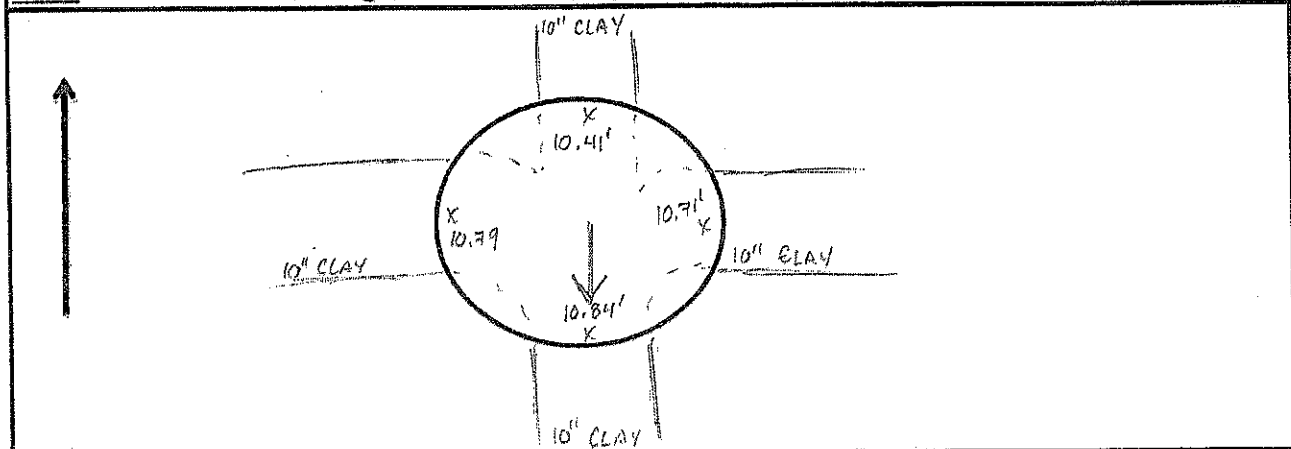
Condition	Material	I/I	Photo ID	Comments
Cover 1 (2) 3		0 1 2 3	117-0198	Open Pick Holes
Frame 1 (2) 3		0 1 2 3		
Chimney 1 2 (3)		0 1 2 3		
Corbel 1 2 3		0 1 2 3		
Wall 1 (2) 3		0 1 2 3		
Bench 1 2 3		0 1 2 3		
Invert 1 (2) 3		0 1 2 3		
Steps (1) 2 3		0 1 2 3

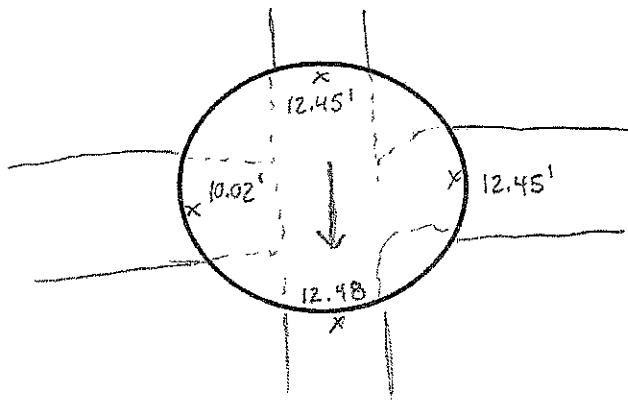
Condition	Material	I/I	Photo ID	Comments
Cover	1 2 ③		0 1 2 3	118-0198	Concrete Pick Holes
Frame	1 2 ③		0 1 2 3		
Chimney	1 2 ③		0 1 2 3		
Corbel	1 2 3		0 1 2 3		
Wall	1 2 ③		0 1 2 3		
Bench	1 2 3		0 1 2 3		
Invert	1 2 ③		0 1 2 3		
Steps	1 2 ③		0 1 2 3

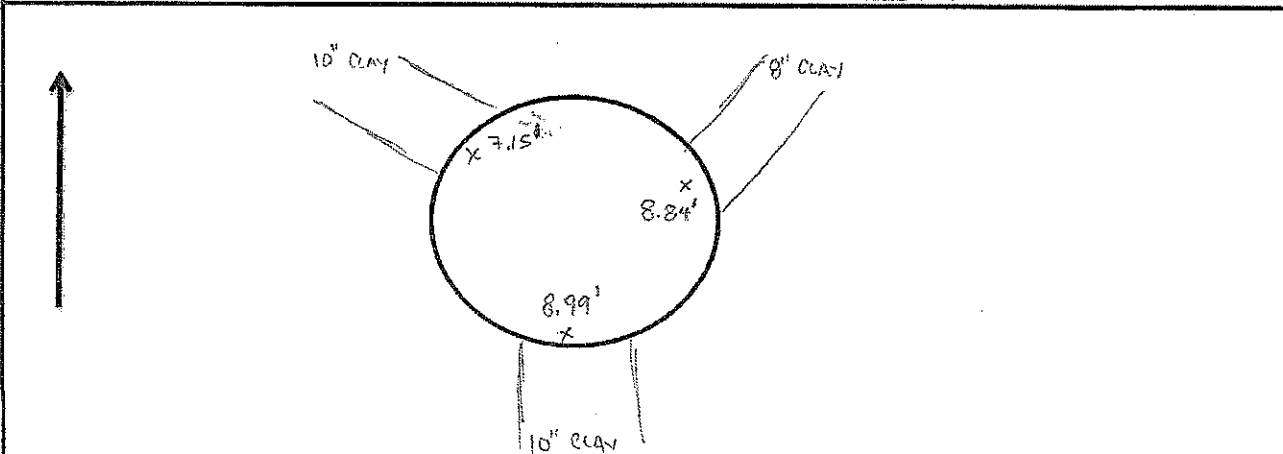
Condition	Material	I/I	Photo ID	Comments
Cover	1 ② 3		0 1 2 3	110-0071	
Frame	1 ② 3		0 1 2 3	110-0210	Open Pick Holes
Chimney	1 ② 3		0 1 2 3	110-0211	
Corbel	1 2 3		0 1 2 3		
Wall	1 2 ③	PRECAST	0 1 2 3	<input checked="" type="checkbox"/>	SEEPAGE 6' FROM BOTTOM
Bench	1 2 3		0 1 2 3		
Invert	1 ② 3		0 1 2 3		
Steps	① 2 3		0 1 2 3

☒ Evidence of Surge Surge Depth 24 (in)

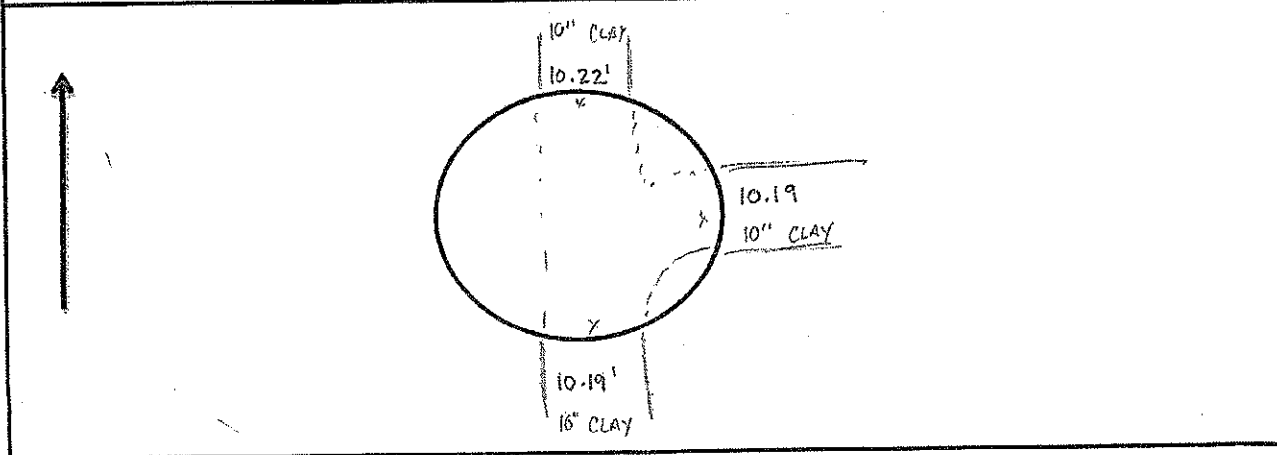
Condition	Material	I/I	Photo ID	Comments
Cover	1 2 <u>3</u>		0 1 2 3	110-0040	
Frame	1 <u>2</u> 3		0 1 2 3	110-0041	
Chimney	1 2 <u>3</u>		0 1 2 3	110-0042	
Corbel	1 2 3		0 1 2 3	110-0043	
Wall	1 2 <u>3</u>	PRECAST	0 1 2 3		MOISTURE BOTTOM 4'
Bench	1 2 3		0 1 2 3	110-0167	Open Pick hole
Invert	1 <u>2</u> 3		0 1 2 3	110-0168	NO APPARENT I/I
Steps	<u>1</u> 2 3		0 1 2 3

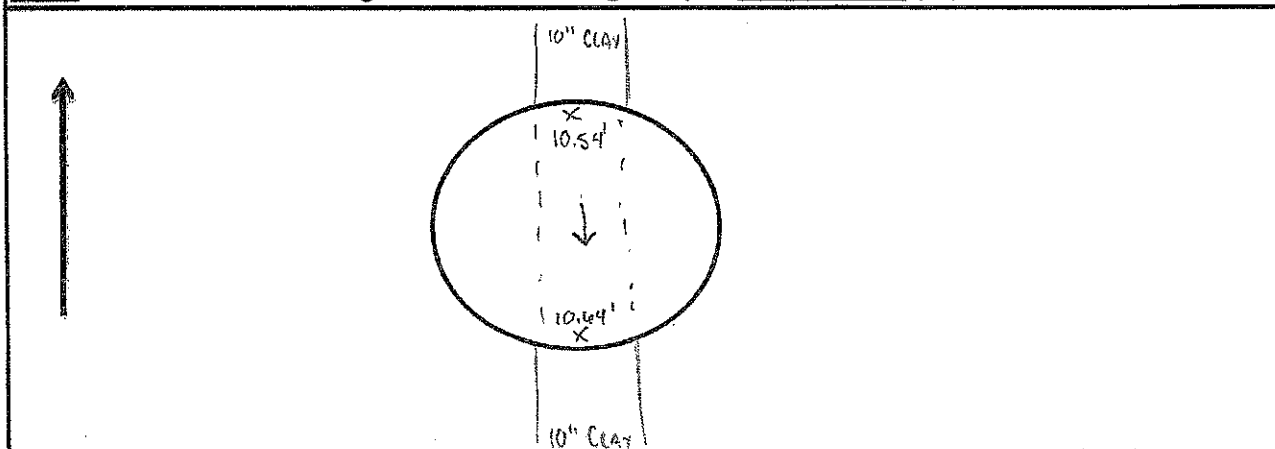
Condition	Material	I/I	Photo ID	Comments
Cover	1 (2) 3		0 1 2 3	110-0048	
Frame	1 (2) 3		0 1 2 3	110-0178	Open PICK holes
Chimney	1 (2) 3		0 1 2 3		
Corbel	1 2 3		0 1 2 3		
Wall	1 (2) 3	BRICK-LINED?	0 1 2 3		
Bench	1 2 3		0 1 2 3		
Invert	1 (2) 3		0 1 2 3		
Steps	1 2 3		0 1 2 3

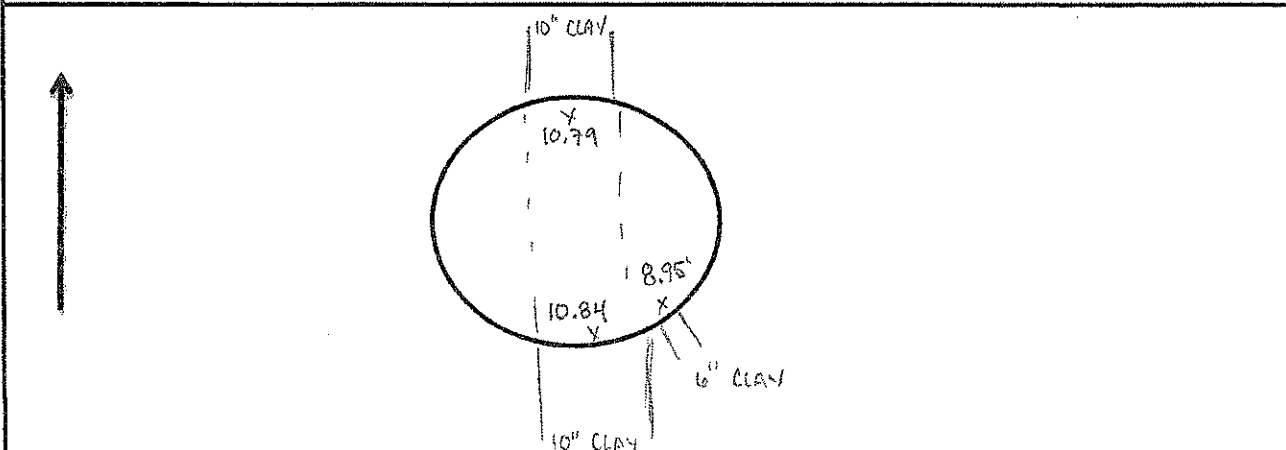
Condition	Material	I/I	Photo ID	Comments
Cover	1 (2) 3		0 1 2 3	110-0049	
Frame	1 (2) 3		0 1 2 3	110-0184	Open Pick holes
Chimney	1 (2) 3		0 1 2 3	110-0175	
Corbel	1 2 3		0 1 2 3		
Wall	1 2 (3)	LINED BRICK	0 1 2 3		
Bench	1 2 3		0 1 2 3		
Invert	1 (2) 3		0 1 2 3		
Steps	(1) 2 3		0 1 2 3

1 = Bad Condition 2 = Poor Condition 3 = Good Condition	0 = No I/I 1 = Low Flow 2 = Medium Flow 3 = High Flow
<input checked="" type="checkbox"/> Evidence of Surge Surge Depth <u>12</u> (in)

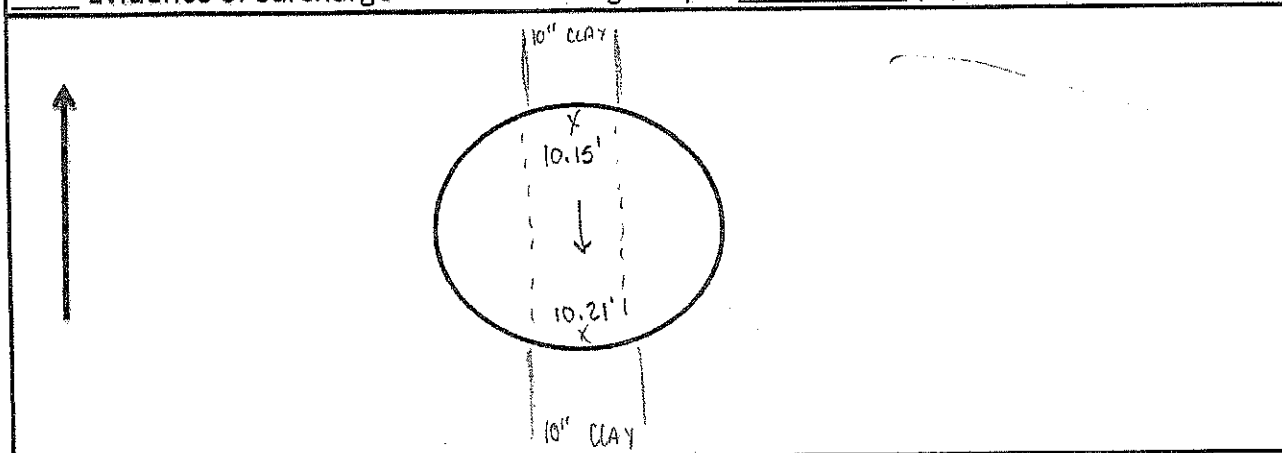
Condition	Material	I/I	Photo ID	Comments
Cover	1 ② 3		0 1 2 3	110-0650	
Frame	1 ② 3		0 1 2 3	110-0186	Open Pick holes
Chimney	1 2 ③		0 1 2 3	110-0187	
Corbel	1 2 3		0 1 2 3		
Wall	1 2 ③	LINED BRICK	0 1 2 3		MOISTURE BOTTOM 12"
Bench	1 2 3		0 1 2 3		
Invert	1 ② 3		0 1 2 3		
Steps	① 2 3		0 1 2 3

☒ Evidence of Surge

Surge Depth 6 (in)

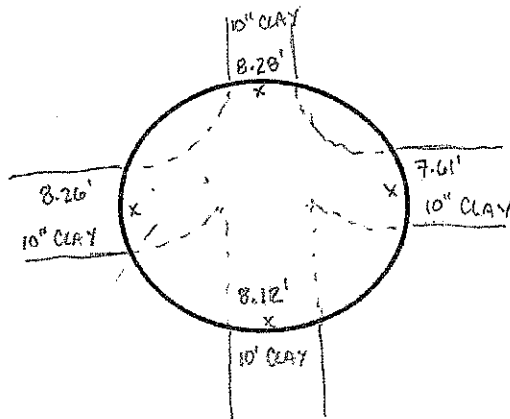
Condition	Material	I/I	Photo ID	Comments
Cover	1 2 ③		0 1 2 3	110-0040	
Frame	1 2 ③		0 1 2 3	110-0040	
Chimney	1 2 ③		0 1 2 3	110-0174	Concealed pick hole
Corbel	1 2 3		0 1 2 3	110-0175	
Wall	1 2 ③	PRECAST	0 1 2 3	<input checked="" type="checkbox"/>	MOISTURE BOTTOM 4'
Bench	1 2 3		0 1 2 3		
Invert	1 ② 3		0 1 2 3		
Steps	① 2 3		0 1 2 3

☒ Evidence of Surge

Surge Depth 12 (in)

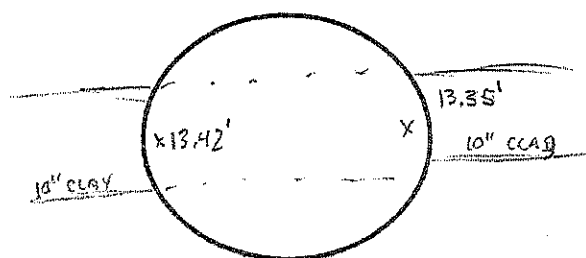
Condition	Material	I/I	Photo ID	Comments
Cover	1 2 (3)		0 1 2 3	110-0055	
Frame	1 2 (3)		0 1 2 3	110-0182	Open Pick holes
Chimney	1 2 (3)		0 1 2 3	110-0183	
Corbel	1 2 3		0 1 2 3	110-0190	Open Pick holes
Wall	1 2 (3)	PRECAST	0 1 2 3	X	BOTTOM RISER WET
Bench	1 2 3		0 1 2 3	110-0191	
Invert	1 (2) 3		0 1 2 3	110-0192	
Steps	(1) 2 3		0 1 2 3	110-0193	Riser shifted

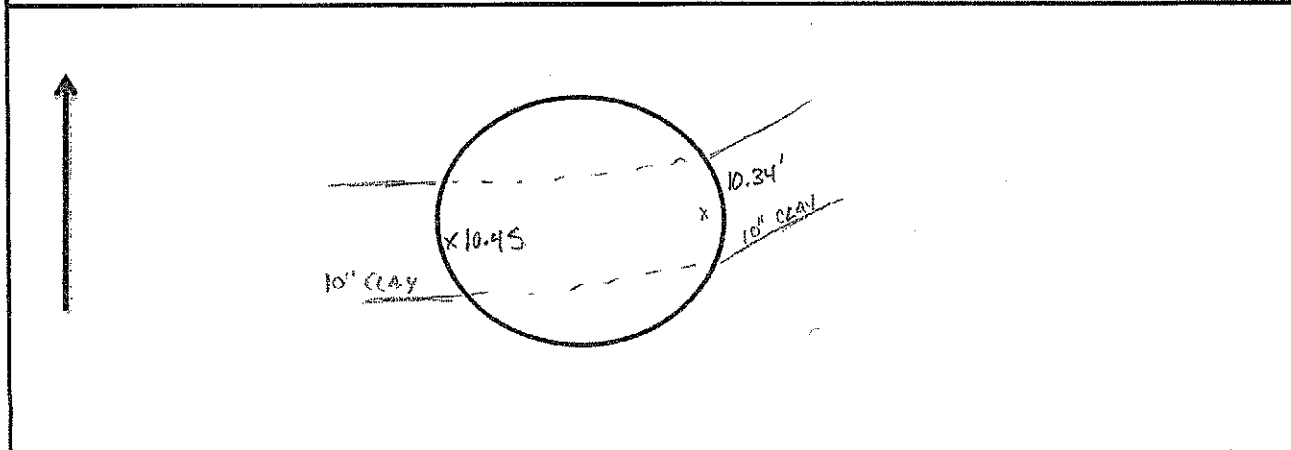
Condition	Material	I/I	Photo ID	Comments
Cover	1 2 (3)		0 1 2 3	118-0856	
Frame	1 2 (3)		0 1 2 3	118-0181	Open Pick holes
Chimney	1 2 (3)		0 1 2 3		
Corbel	1 2 3		0 1 2 3		
Wall	1 2 (3)	PRECAST	0 1 2 3		
Bench	1 2 3		0 1 2 3		
Invert	1 (2) 3		0 1 2 3		
Steps	(1) 2 3		0 1 2 3

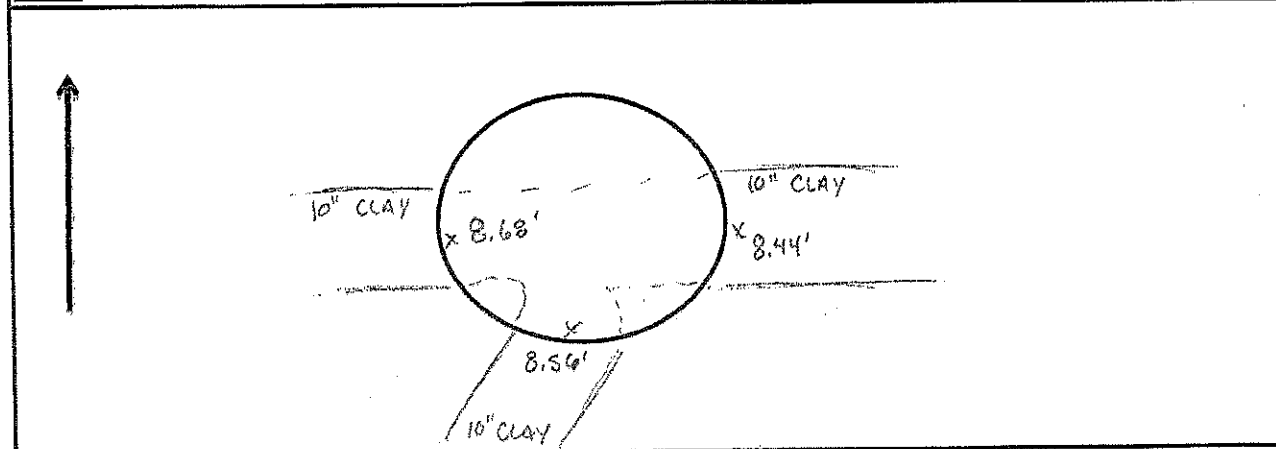
Condition	Material	I/I	Photo ID	Comments
Cover	1 (2) 3		0 1 2 3	110-0059	
Frame	1 (2) 3		0 1 2 3	110-0178	Open Pick holes
Chimney	1 (2) 3		0 1 2 3	110-0180	
Corbel	1 2 3		0 1 2 3		
Wall	1 2 (3)	PRECAST	0 1 2 3		GROUNDWATER ON WALLS
Bench	1 2 3		0 1 2 3		
Invert	1 (2) 3		0 1 2 3		
Steps	1 (2) 3		0 1 2 3

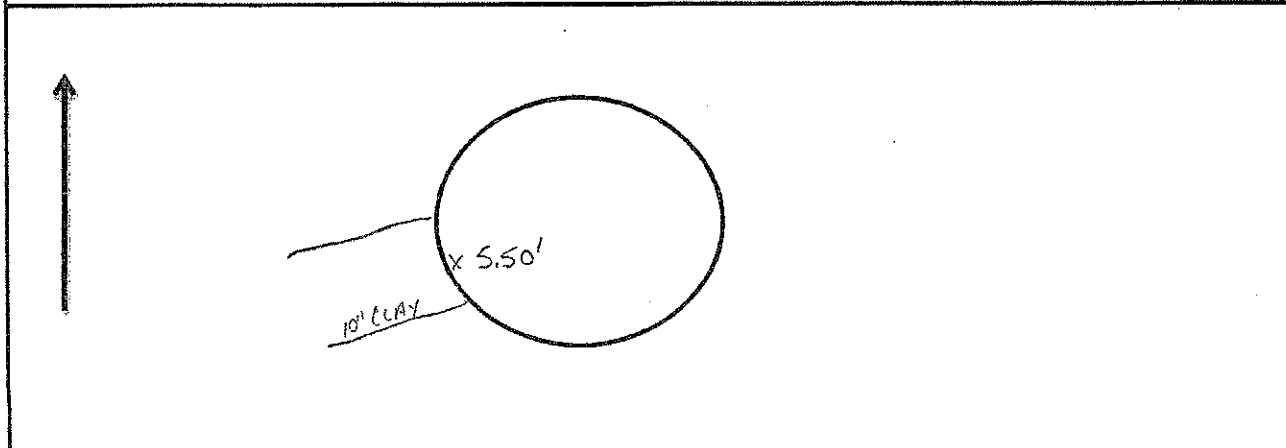
Condition	Material	I/I	Photo ID	Comments
Cover	1 <u>2</u> 3		0 1 2 3	110-0060	
Frame	1 2 <u>3</u>		0 1 2 3	110-0178	Open Pick holes
Chimney	1 2 <u>3</u>		0 1 2 3		
Corbel	<u>1 2 3</u>		0 1 2 3		
Wall	1 2 <u>3</u>	PRECAST	0 1 2 3		
Bench	<u>1 2 3</u>		0 1 2 3		
Invert	1 <u>2</u> 3		0 1 2 3		
Steps	<u>1 2 3</u>		0 1 2 3

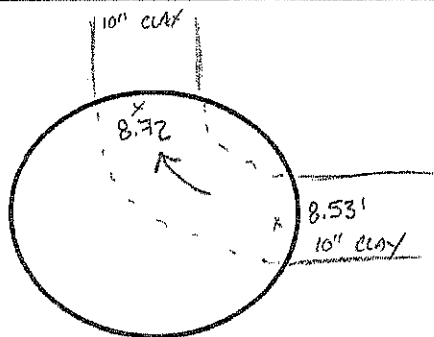
Condition	Material	I/I	Photo ID	Comments
Cover	1 2 <u>3</u>		0 1 2 3	110-0061	
Frame	1 2 <u>3</u>		0 1 2 3	110-0176	Open Pick hole
Chimney	1 2 <u>3</u>		0 1 2 3		
Corbel	<u>1</u> 2 3		0 1 2 3		
Wall	1 2 <u>3</u>	PRECAST	0 1 2 3		
Bench	<u>1</u> 2 3		0 1 2 3		
Invert	1 <u>2</u> 3		0 1 2 3		
Steps	1 <u>2</u> 3		0 1 2 3

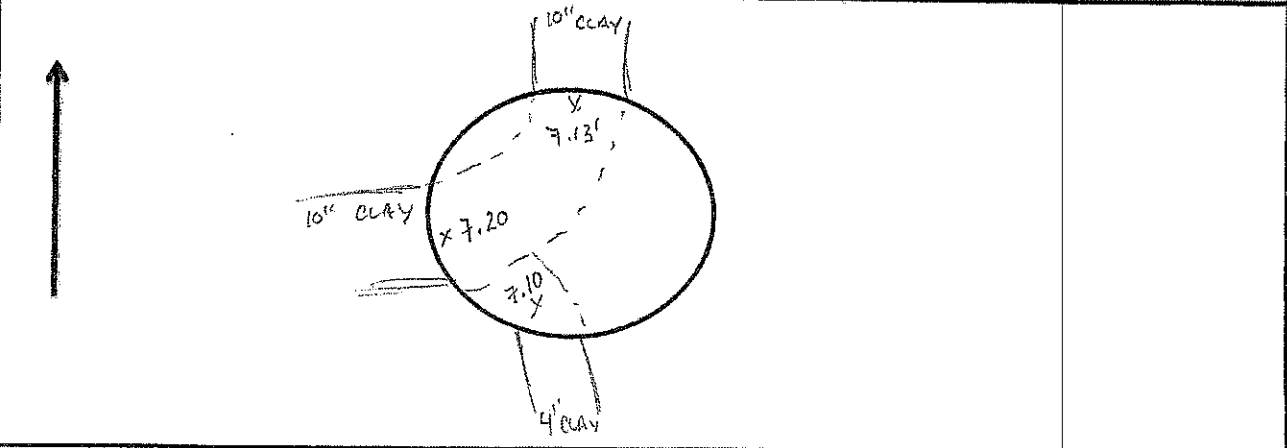
Condition	Material	I/I	Photo ID	Comments
Cover	1 2 (3)		0 1 2 3	110-0064	
Frame	1 2 (3)		0 1 2 3	110-0177	Open Pick hole
Chimney	1 2 (3)		0 1 2 3		
Corbel	1 2 3		0 1 2 3		
Wall	1 2 (3)	PRECAST	0 1 2 3		
Bench	1 2 3		0 1 2 3		
Invert	1 2 (3)		0 1 2 3		
Steps	1 (2) 3		0 1 2 3

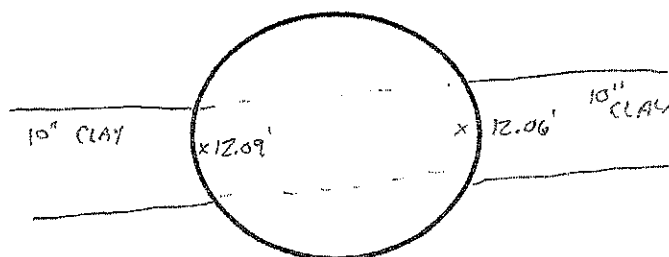
Condition	Material	I/I	Photo ID	Comments
Cover	1 (2) 3		0 1 2 3	110-0066	
Frame	1 (2) 3		0 1 2 3	110-0196	Open Pick holes
Chimney	1 2 (3)		0 1 2 3	110-0197	
Corbel	1 2 3		0 1 2 3		
Wall	1 2 (3)	LINED BRICK	0 1 2 3	*	MOISTURE BOTTOM 4'
Bench	1 2 3		0 1 2 3		
Invert	1 (2) 3		0 1 2 3		
Steps	(1) 2 3		0 1 2 3

☒ Evidence of Surge

Surge Depth 24 (in)

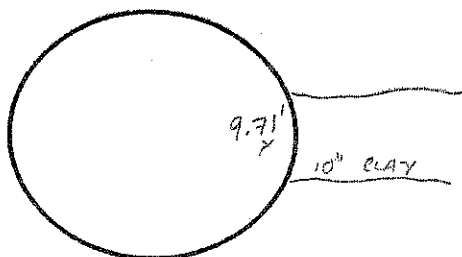
Condition	Material	I/I	Photo ID	Comments
Cover	1 (2) 3		0 1 2 3	110-0070	
Frame	1 (2) 3		0 1 2 3	110-0207	Open Pick Holes
Chimney	1 2 (3)		0 1 2 3	110-0208	Riser Shifting
Corbel	1 2 3		0 1 2 3	110-0209	
Wall	1 (2) 3	LINED BRICK	0 1 2 3	<input checked="" type="checkbox"/>	MOISTURE BOTTOM 4'
Bench	1 2 3		0 1 2 3		
Invert	1 (2) 3		0 1 2 3		
Steps	(1) 2 3		0 1 2 3

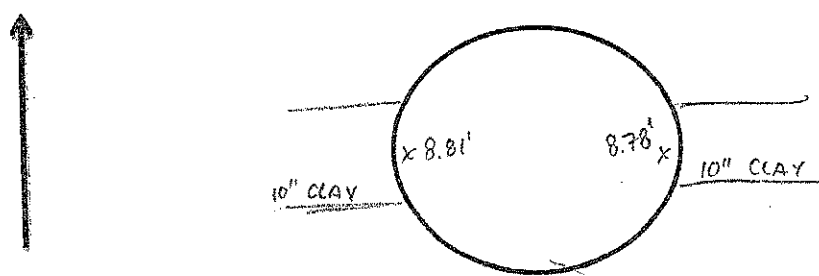
Condition	Material	I/I	Photo ID	Comments
Cover	1 2 <u>3</u>		0 1 2 3	110-0009	
Frame	1 2 <u>3</u>		0 1 2 3	110-0204	open Risk Holes
Chimney	1 2 <u>3</u>		0 1 2 3	110-0205	
Corbel	1 2 3		0 1 2 3		
Wall	1 2 <u>3</u>	CIP CON C.	0 1 2 3	★	WATER SEEPAGE
Bench	1 2 3		0 1 2 3		
Invert	1 2 <u>3</u>		0 1 2 3		
Steps	<u>1</u> 2 3		0 1 2 3
